REPORT ON SHIPPING CASUALTIES

2014, 2015 & 2016

DIRECTORATE GENERAL OF SHIPPING, INDIA

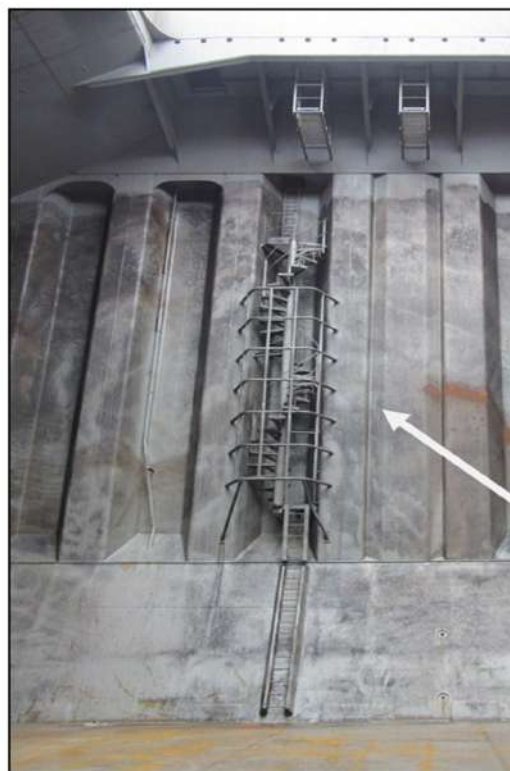
An Australian ladder on a bulk carrier, however, without the enclosing trunk. (Image for illustration purpose only)

Australian ladder on this particular vessel was a spiraling type. A steel trunk arrangement was enclosing the ladder. The trunk was fitted to provide protection to persons, using the ladder, from falling as well as to protect the ladder against damages from grabs, bulldozers and other equipment while loading and unloading of cargo in the hold would be in progress.

There were no other means or openings available for ventilation of the trunk space. At the time of incident, the cargo hold was 70-80% full of coal cargo and therefore the bottom opening got covered with coal. This caused the bottom opening to get blocked shut. Since the cargo was coal, the trunk space got filled with toxic gases. Although gas sampling record was being maintained for the cargo hold, it did not include the Australian ladder's trunk space.

(v) There was a deficiency in the design of the Australian ladder as no ventilation had been provided in the Australian ladder's trunk space, other than the openings at top and at bottom.

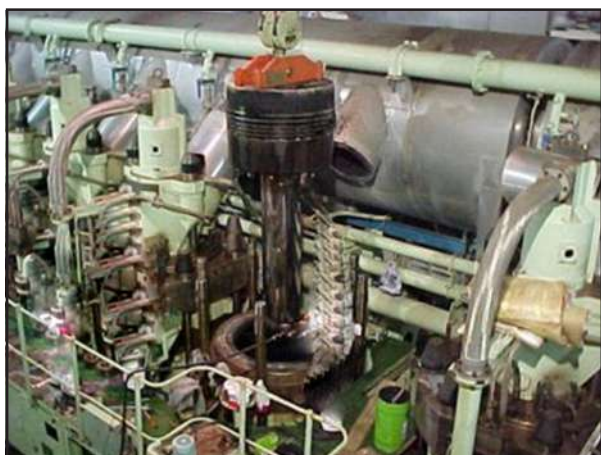
Piston hanging from crane
(Image for illustration purpose only)

However during one roll of the vessel, the rope stays failed to restrain movement of the hanging piston adequately and it went on to hit one of the supports. A plate, which was supporting the stuffing box, slipped off and fell down on the pipe below it. While falling further down the plate got deflected towards the staircase and landed on the helmet of 3rd engineer, inflicting injury to his forehead and nose. 3rd engineer was taken to the engine control room (ECR) and administered first aid. He was then shifted to hospital wherein he was kept under constant supervision for the next few hours till the bleeding had completely stopped. Skin closure sutures were applied to close the deep cuts on his forehead and nose.

- (i) Lack of attention and situational awareness by the 3rd engineer.
- (ii) Inadequate securing of the piston as its movement was not sufficiently restrained.

(i) Detailed 'risk assessment' shall be carried out prior undertaking such tasks, including for hazards that may be posed due to the vessel being in open waters.

(iv) All loose objects to be properly secured.

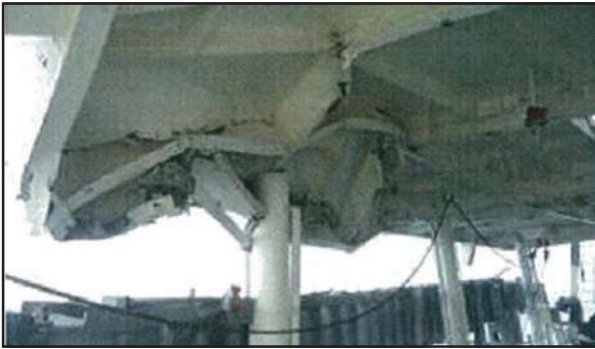
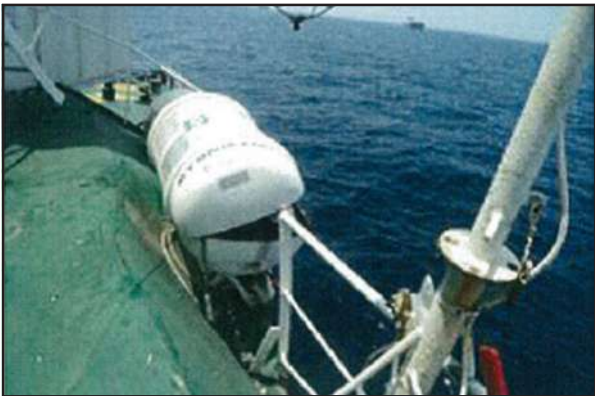
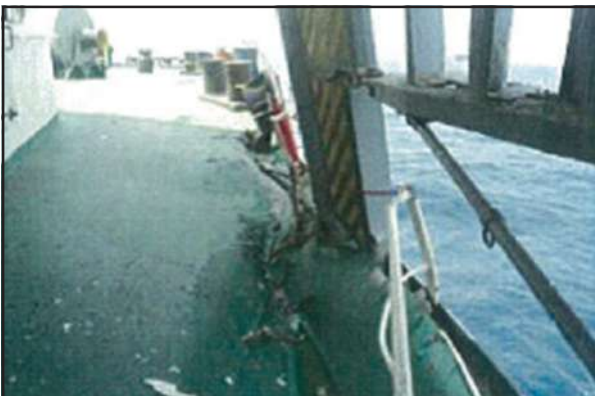
A minute before collision, 'Vessel 1', the bulk carrier put its wheel hard over to starboard, however it was too late. At about 00:02 a.m. the starboard forward part of the tanker vessel, 'Vessel 2' made contact with port quarter of bulk carrier, the 'Vessel 1'.

While there was no casualty or pollution, damages occurred to shell plating and associated strengthening members on 'Vessel 1'.

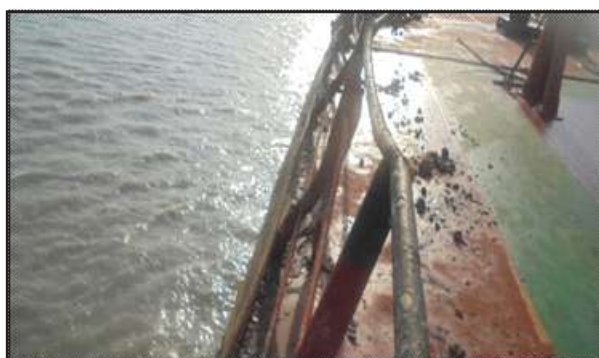
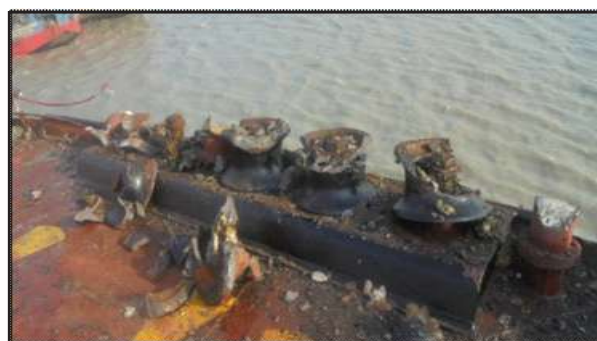
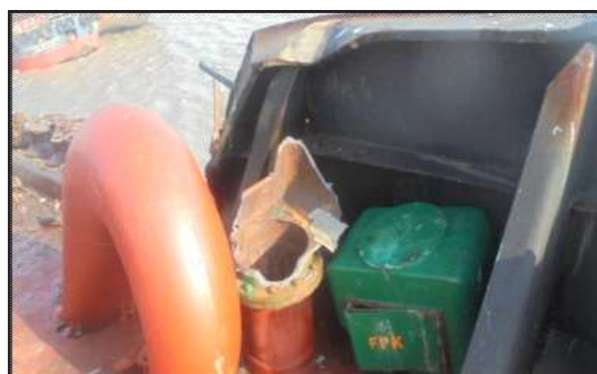
At 11:15 p.m., the bulk carrier made contact with the tanker vessel in vicinity of its No. 1 cargo hold on the port side of the vessel. Railings, bulwark, fish plate, fair lead rollers, gooseneck vent, forepeak tank air vent and forecastle deck plating on 'Vessel 1' in way of the ship side were damaged.

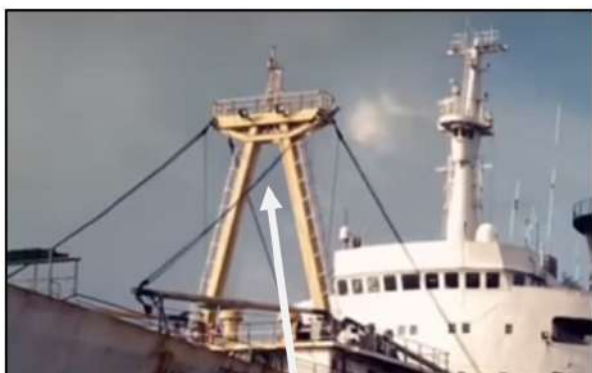
Samson post for derrick

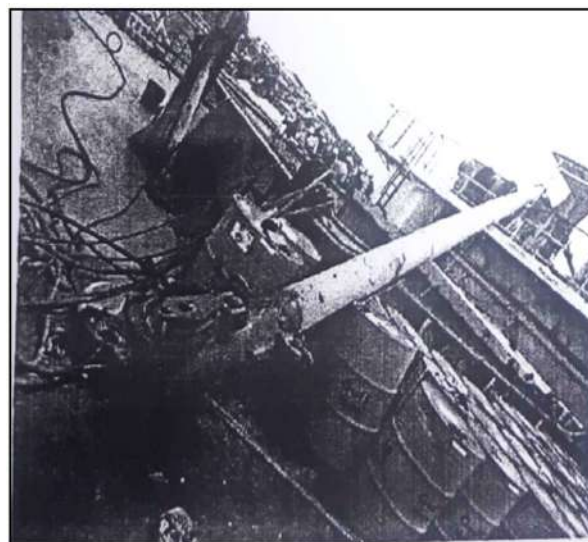
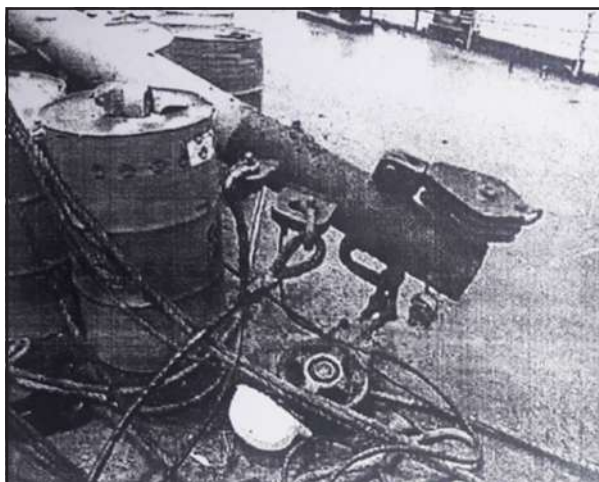
As soon as weight on wire and pin was removed, weight shifted on to the boom causing sudden jerk. This shifting of weight and jerk broke the entire platform, causing the deceased seaman to fall down, along with broken railings, on top of the hatch cover of cargo hold below. He got grievously hurt. He later succumbed to his injuries.

- (i) Poor risk assessment and work planning. No analysis had been made of the load bearing capacity of the mast's platform before deciding to transfer weight on to the same. Also due consideration not given to the fact that load during a jerk could be multiple times higher than the static weight.

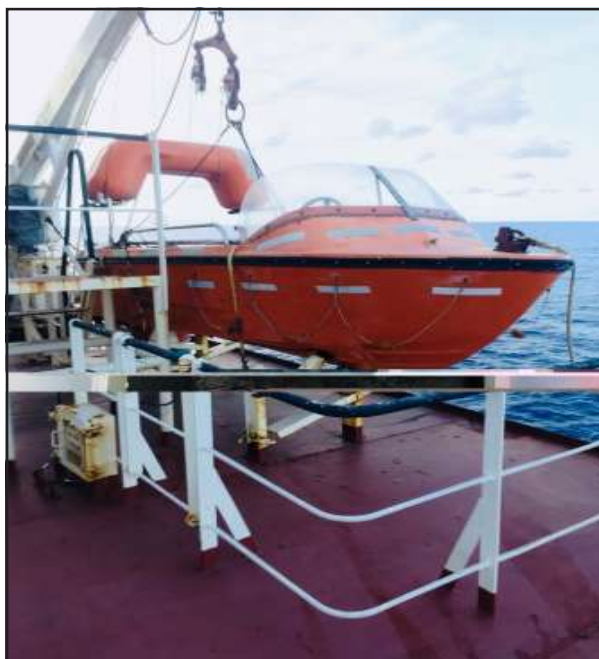
**Ship side railings not fitted, by design
(Image for illustration only)**

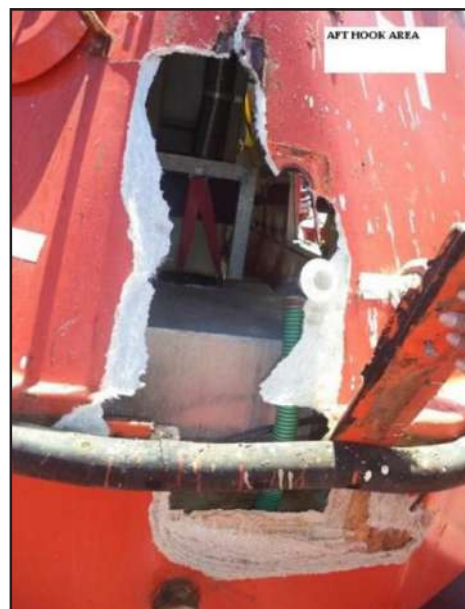
The entire weight of the lifeboat shifted on to the aft hook with a sudden jerk. As a result, the aft hook got sheared off from the lifeboat's hull resulting in the lifeboat falling freely into the sea underneath.

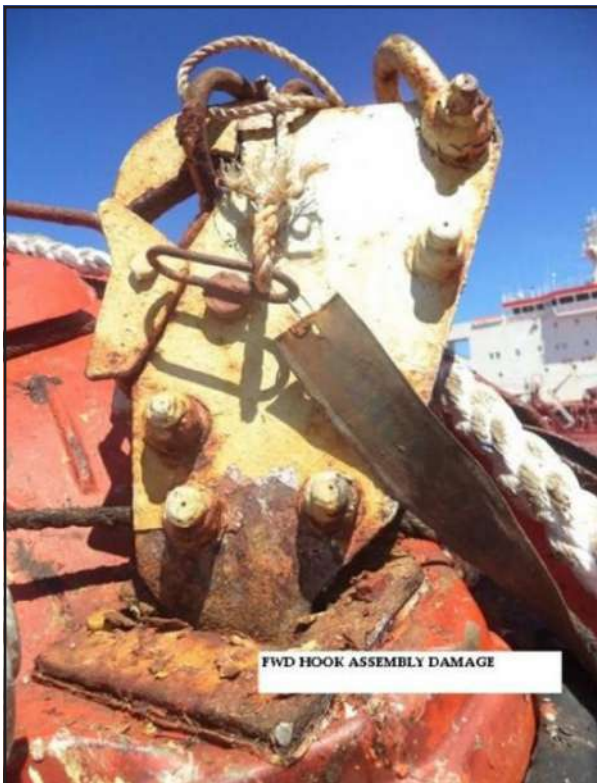
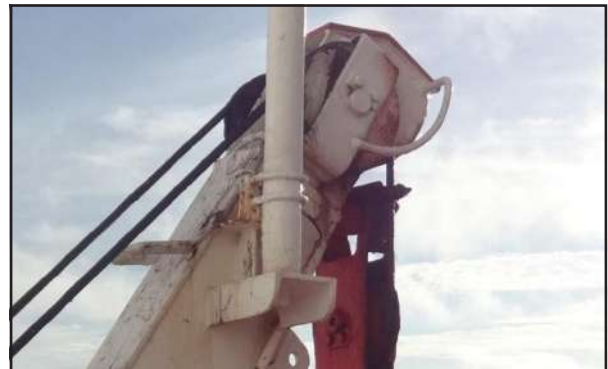
Inadequate inspection maintenance and lubrication of lifeboat's falls' wires.

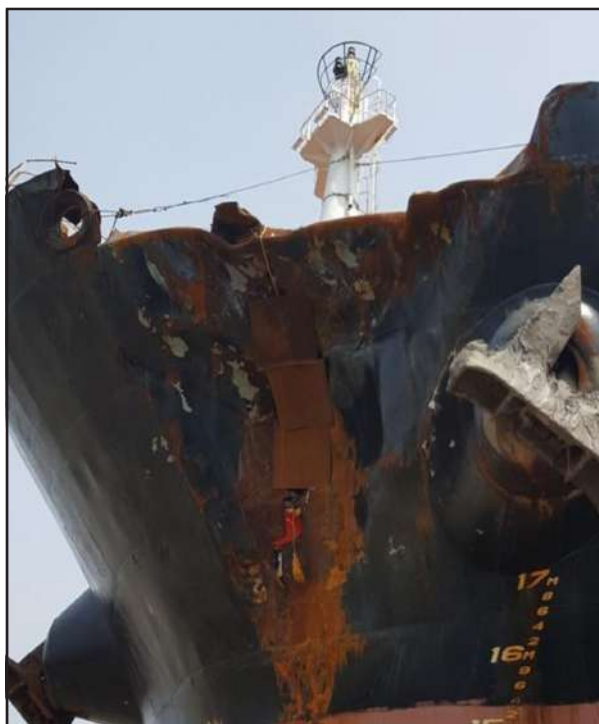
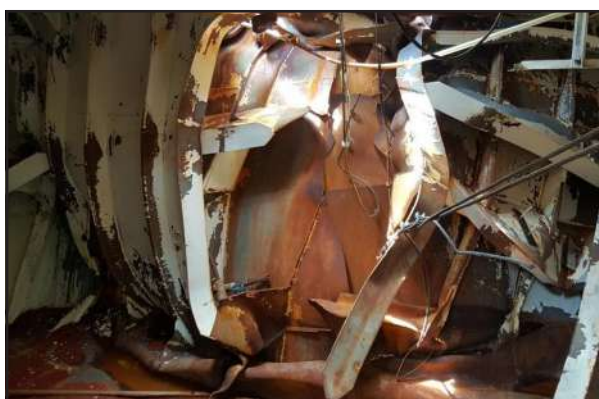
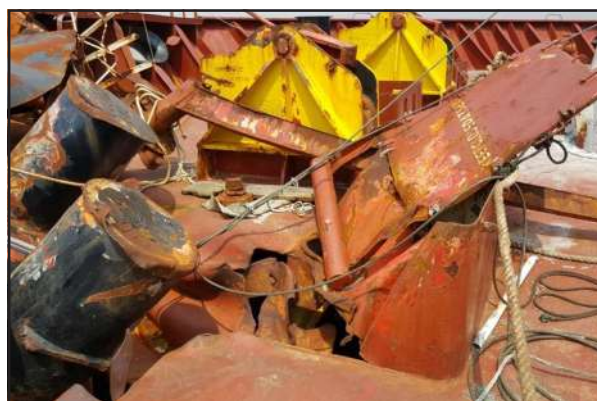
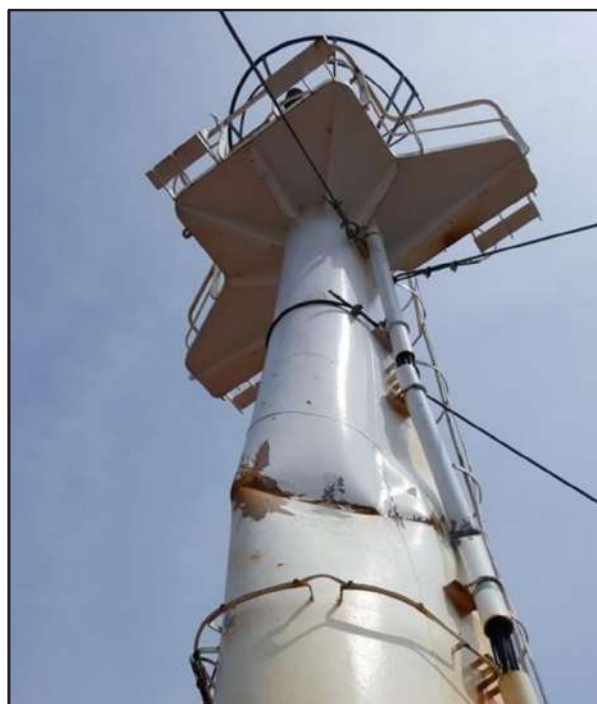
Initial impact was with forward part of tanker vessel. The general cargo vessel swung to its port due to the impact, came starboard side along-side on the port side of crude oil tanker and made contact on the manifold rail of crude oil tanker with its starboard quarter. Both vessels then moved apart due to the resultant momentum. There were no injuries and no pollution as a result of the collision, however both vessels suffered structural damages.

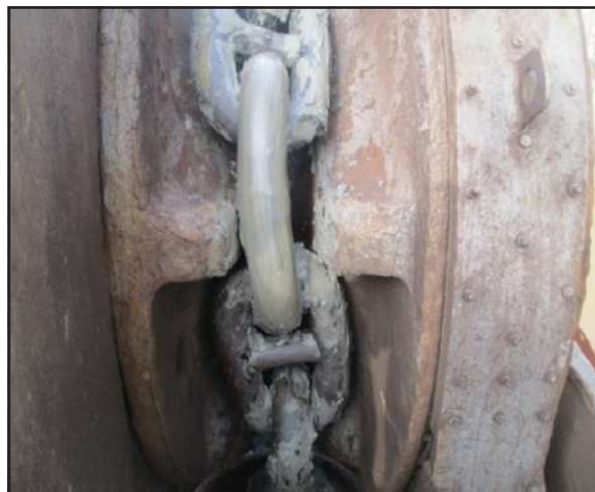
Officer of watch on 'Vessel 1' called 'Vessel 2' on VHF requesting wider berth, but 'Vessel 2' did not reply. It rather kept approaching closer. 'Vessel 2', at this moment was doing a speed of approx. 04 knots. Officer of watch on 'Vessel 1' called the port control and informed about the situation. The port control also called up 'Vessel 2', however no response was received. Eventually 'Vessel 2' made contact with 'Vessel 1' on its port bow. In the process, anchor cable of 'Vessel 1' got entangled with flukes of port anchor of 'Vessel 2'.

Bent link of the anchor chain
