DGS Circular 46 of 2025

Casualty Branch Circular – 05 of 2025

Collision / Contact damage between

MANTA NIGAR and JAG RADHA at P & V anchorage, Mumbai on 02.08.2024

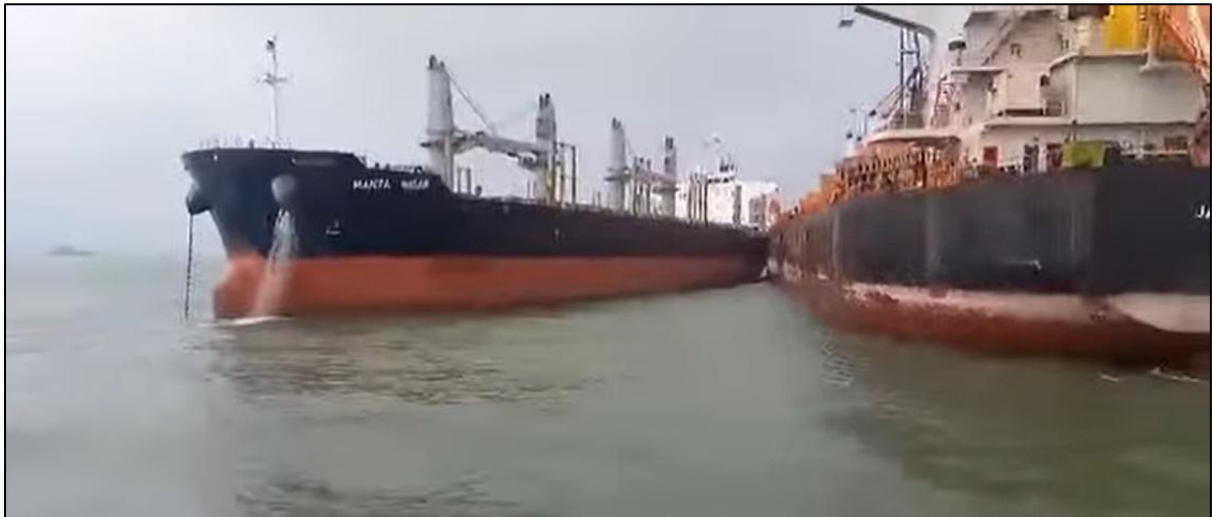
Figure 1: Manta Nigar Collision

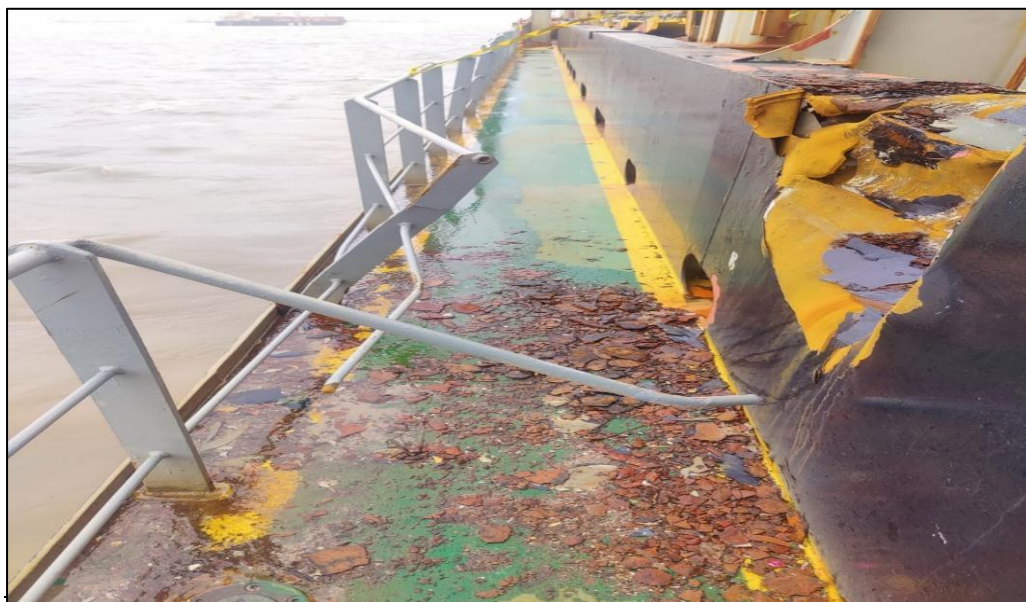
Consequently, both vessels sustained hull damage. In addition, M.V. Manta Nigar suffered damage to her accommodation area, deck railings, fish plate, cargo securing post, port side lifeboat deck, and propeller blades.

Figure 4: Damages observed on board Vessel Manta Nigar

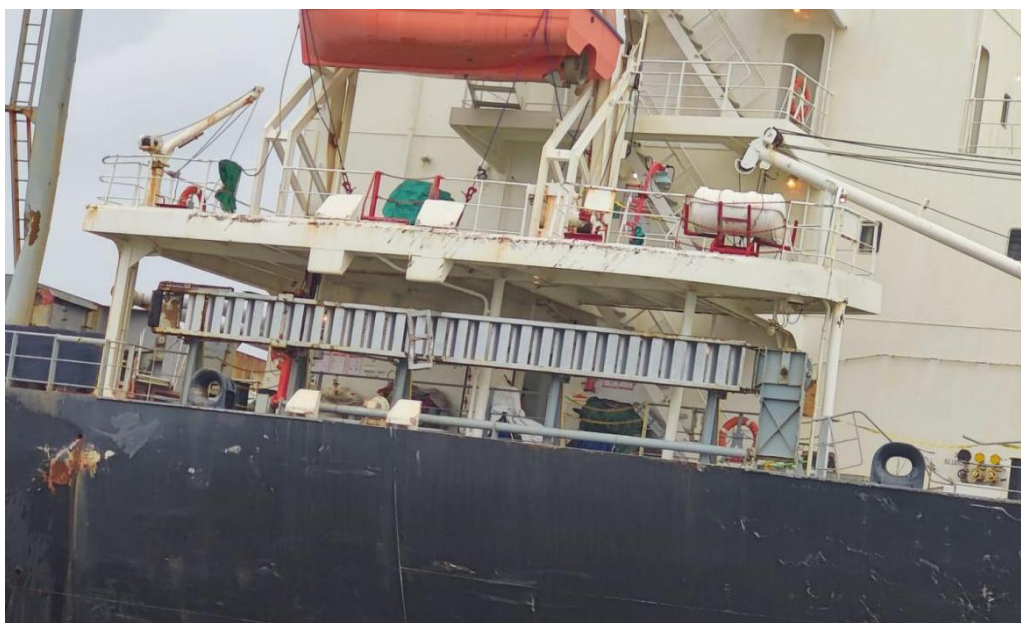
At 0919 hours, while manoeuvring towards the berth, the M.V. Manta Nigar's propeller became entangled with the port anchor chain of the anchored vessel M.V. Jag Radha. As a result, M.V. Manta Nigar's port quarter struck M.V. Jag Radha's port bow in the forecastle area. The master and pilot of M.V. Manta Nigar immediately stopped the engine.

Figure 5: Damages seen from port side on vessel Manta Nigar
