MARINE SAFETY INVESTIGATION REPORT -HALF YEARLY

— January - June (2025)

DIRECTORATE GENERAL OF SHIPPING
MINISTRY OF PORTS, SHIPPING & WATERWAYS
GOVERNMENT OF INDIA

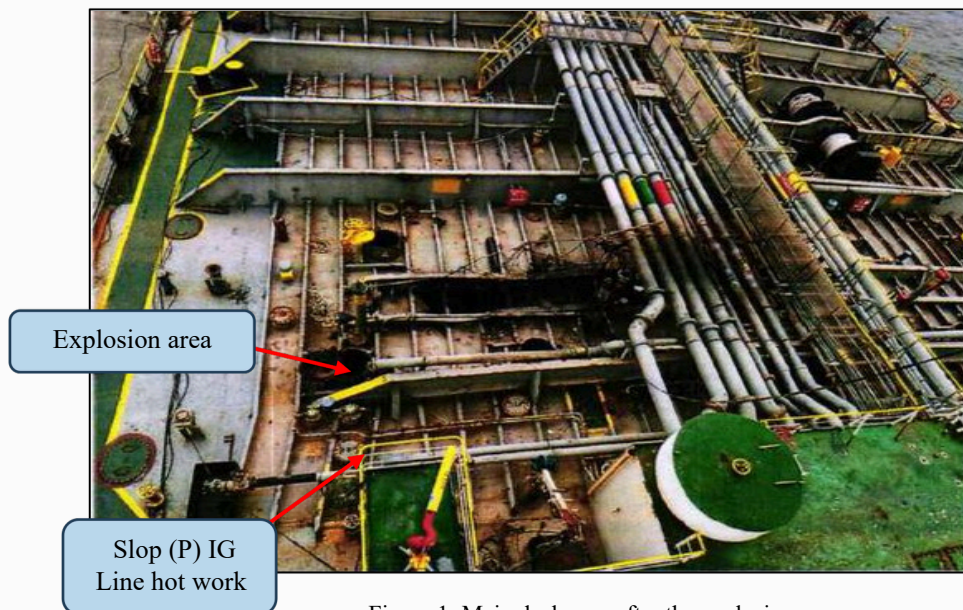
Figure 1: Main deck area after the explosion

On 10th November 2023 at 0005 hrs. there was an explosion followed by fire on the tanker while the repairs were being carried out near the vicinity of Slop tank (port) which led to the fatality of one shore personnel and injuries to three others from the shore team. The vessel's tank dome and the internals of the Cargo Oil Tank No.7 (port) and Slop tank (port) were damaged and the main deck plating between Frame No. 49-50 were badly ruptured. There was no report of environmental pollution following the casualty or damage to the Port infrastructure following the incident.

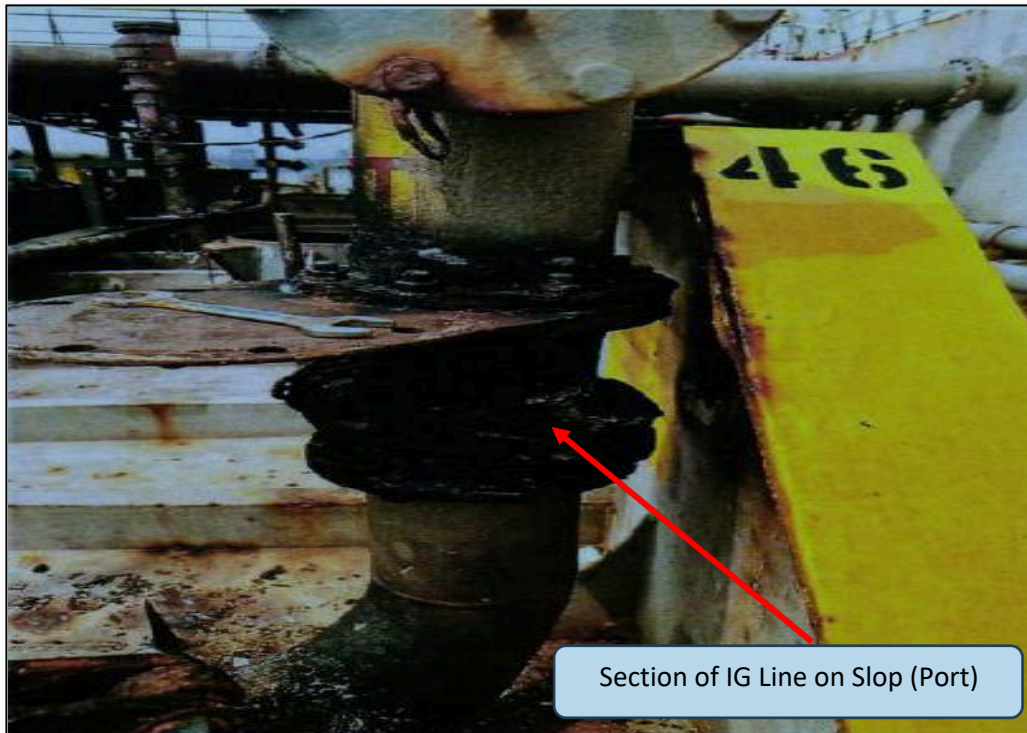
Figure 3: Section of Inert Gas line where unscheduled job was carried out

An Indian flagged tanker was undergoing repairs that included renewal of sections of the Inert Gas (IG) pipeline on main deck at the Port of Chennai at repair berth since 30th October 2023 after taking the necessary permissions from Port authorities and PESO. Repairs were on going on the boiler and hence additional repairs were planned on the deck area by the onsite team.

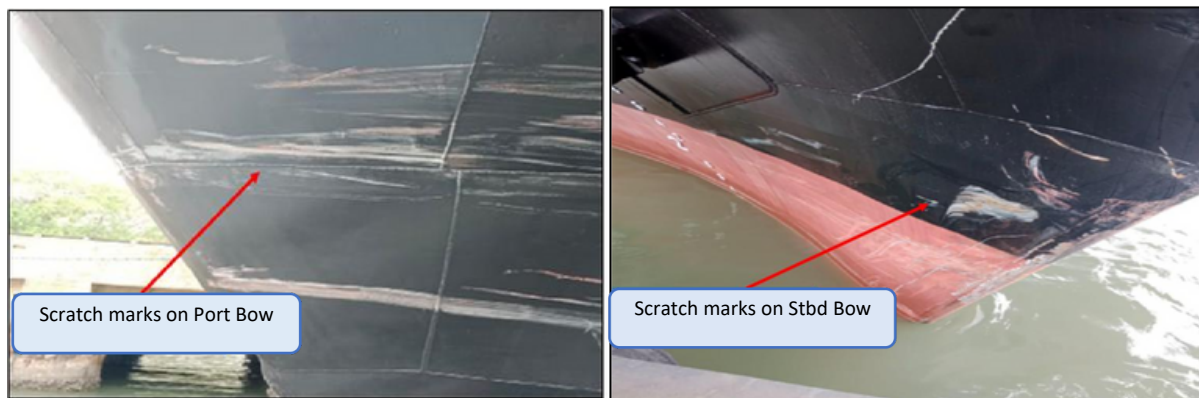
Figure 2: Scratches on port bow and starboard bow of merchant vessel.

As per the fishing vessel's statement, one crew member in the wheelhouse noticed a ship approaching. They started the engine and attempted to move, intending to release the anchor, but inadvertently steered toward the approaching vessel. Unable to raise the anchor, they slackened the anchor line, leading to the collision with the merchant vessel.
