DGS Circular 42 of 2025

Casualty Branch Circular – 04 of 2025

Subject: Death of seafarer due to fall from Crane Cabin

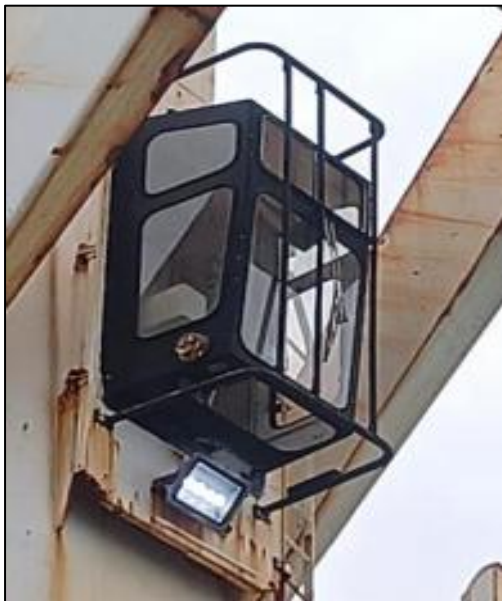
Figure 2: Crane Operator cabin: Outside view

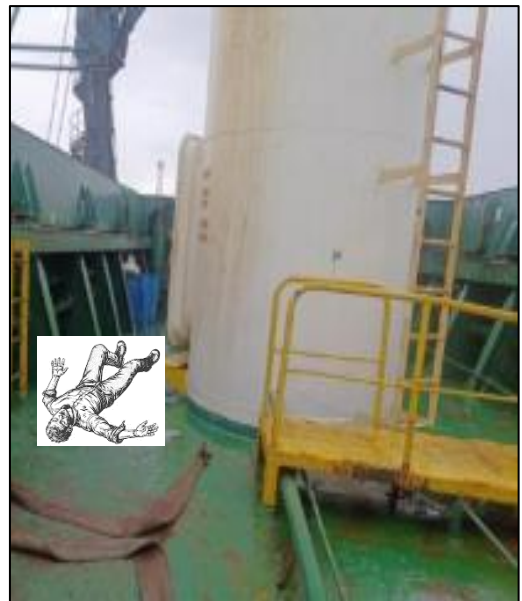
Figure 3: Location where the seafarer landed after the fall

On the morning of 22 May 2024, while the vessel remained at anchor awaiting berthing instructions, two ordinary seafarers were tasked with cleaning the interiors of the cargo crane cabins, which required maintenance after the cargo operations in Chittagong. About 30 minutes into the work, one of the seafarers, fell from the cabin of cargo crane no. 1 onto the cross-deck between cargo holds 1 and 2, a drop of around 12 metres. Despite the crew's immediate response, the seafarer sustained fatal injuries. The safety investigation determined that the most probable cause of the fall was the failure of the sealing mechanism of the bottom window in the cabin of cargo crane no. 1.

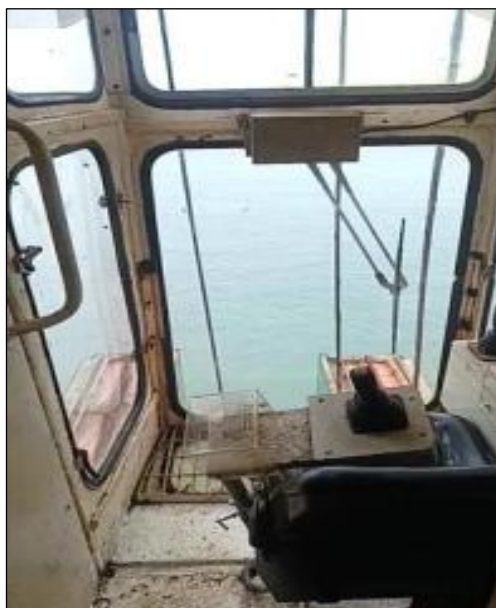
Figure 4: Crane Operator Cabin - Inside view

- a. Failure of bottom window assembly: The seafarer fell through the bottom window, which gave under the seafarer's weight.

- b. **Glass Design Limitation:** The glass pane and rubber seal were not designed to support any weight.
- c. **Pre-existing Damage:** The glass may have been previously weakened.
- d. **Seal Failure:** The rubber seal (double C-channel type) possibly failed under weight of the seafarer.
- e. **Corrosion:** Thinning of metal around the window frame may have weakened the structure.
- f. **No PPE Used:** The seaman was not wearing a safety harness while working at height, where there is risk of fall injury.
- g. **Absence of Safety Barriers:**
 - (i) No physical guard remained after grating was removed.
 - (ii) No alarms or interlocks to prevent or warn against barrier removal.
 - (iii) No warning signs to alert the seafarer to the hazard.

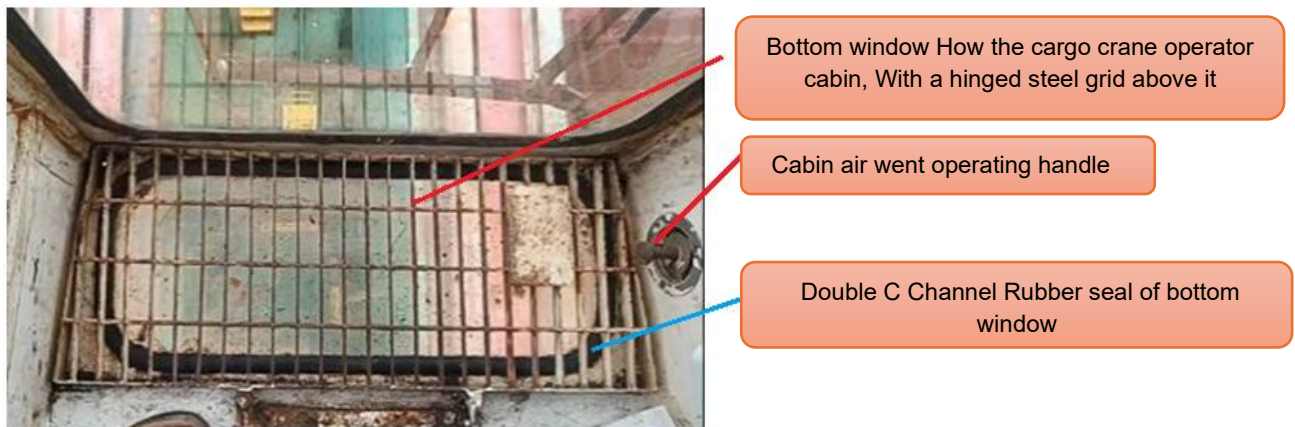
Figure 5 : View of the Crane cabin internal structure / grating arrangement

- a. **Grating Removal:** The protective steel grating over the window was removed to access the glass for cleaning due to seized cabin air vent handle. Normally, the grating is swung out to clean the glass, but due to the obstruction from seized air vent handle, the seafarer had to remove it completely, leaving the fragile glass exposed

- a. **Safety Officer's Inspections¹**: Reinforce the safety officer's inspection program² to look out for any potential hazards and the means of preventing incidents. The safety officer must ensure that each accessible part of the ship has a health and safety inspection at least once every three months, or more frequently if there have been substantial changes in the conditions of work.
- b. **Install Functional Safety Systems**: Introduce interlocks, alarms, or mechanical restraints to prevent removal of safety barriers or to detect unsafe configurations.
- c. **Design Improvements: Redesign critical components** such as gratings and windows—to allow safe maintenance and cleaning without the need to remove

protective features. Install additional safety barriers, such as transverse steel bars, below exposed areas (in this case the crane operator cabin bottom window) where there is a risk of fall injury.
