भारत सरकार / GOVERNMENT OF INDIA
पत्तन, पोत परिवहन और जलमार्ग मंत्रालय
MINISTRY OF PORTS, SHIPPING AND WATERWAYS
नौवहन महानिदेशालय, मुंबई
DIRECTORATE GENERAL OF SHIPPING, MUMBAI

DGS Circular 10 of 2025

Casualty Branch Circular – 02 of 2025

Sub: Collision between merchant vessel and Indian fishing vessels on the West Coast of India

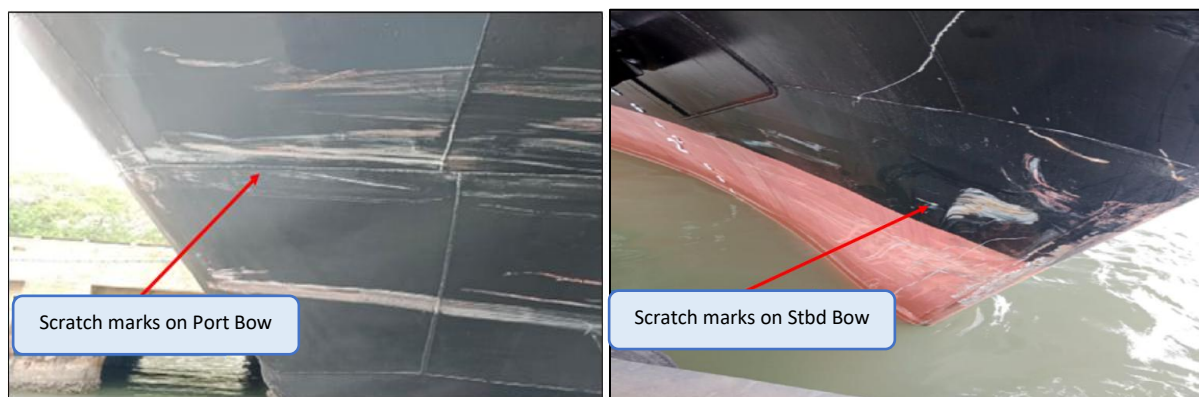
The incident caused the fishing vessel to split into two halves, resulting in the total loss of the vessel. Only four out of the six fishermen were recovered from the water. The merchant vessel sustained damage to the starboard side bow and paint damage along the forward part of the hull.

According to the merchant vessel's statement, the fishing vessel was first noticed on starboard side when it was already very close. Master of the vessel and look out man was on the bridge at that time. The merchant vessel attempted to alter course to port, but the delayed response resulted in a head-on collision with the fishing vessel at 2210 hours, splitting it in two. The vessel slowed down quickly and stopped for search operation. The larger portion of the boat was dragged along the port side, where peeling paint marks were observed. The collision caused damage to the starboard bow and paint scraping on the forward port side hull. (See *Figure 2*)

Figure 2: Scratches on port bow and starboard bow of merchant vessel.

1. Failure to maintain a proper lookout³ is likely the most probable reason for this incident.
2. Delayed notification to Indian Coast Guard and vessels in vicinity about the incident, which resulted in loss of critical response time in rescue efforts, reducing the chances of a successful recovery.

- 4.1 The importance of maintaining a proper lookout and the serious consequences of failing to do so cannot be overstated. Every vessel shall at all times maintain a proper look-out by sight and hearing as well as by all available means appropriate in the prevailing circumstances and conditions so as to make a full appraisal of the situation and of the risk of collision.

- 4.2 The Officer on Watch (OOW) must avoid engaging in any activity that could distract from lookout and watch keeping duties.
- 4.3 When navigating in fishing concentrated areas, the vessel should increase the navigation watch team with additional lookouts, maintaining safe speed and with all engines readily available. Extra attention should be paid to the signal lights of fishing vessels. In close quarter situation, the vessel should use ship's horn, signaling light, and any means of communication or navigational aid to prevent the situation from escalating. It is also important to note that small targets may not be detected by the vessel's radar.

- 4.4 As far as possible, vessels should alter course well in advance to avoid and maintain a safe distance from areas with a high concentration of fishing vessels. The vessel should not cut across areas where fishing vessels are congregated.

- 6.5 **Enhanced Lookout Measures:** Proper lookout practices must be strictly enforced onboard merchant vessels, especially when navigating near fishing zones.
