REPORT ON SHIPPING CASUALTIES

2014, 2015 & 2016

DIRECTORATE GENERAL OF SHIPPING, INDIA

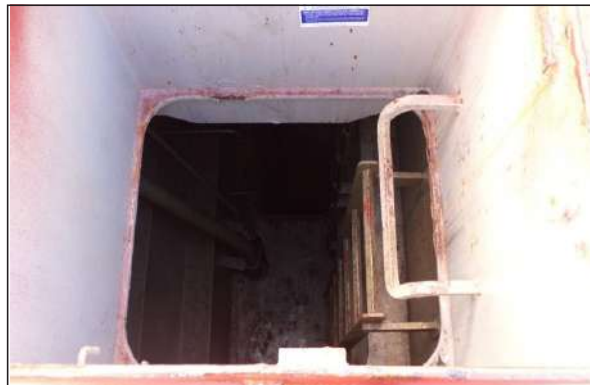
Entrance from main deck to stool space
(Image for illustration purpose only)

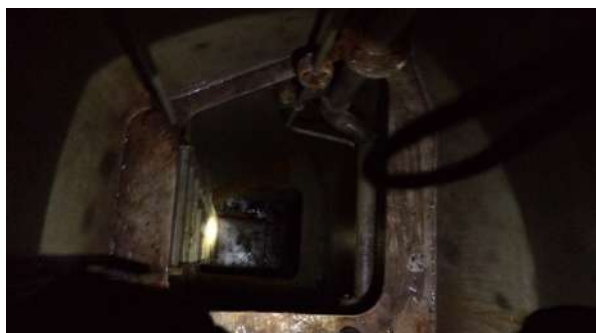
Way down to a lower stool space
(Image for illustration purpose only)

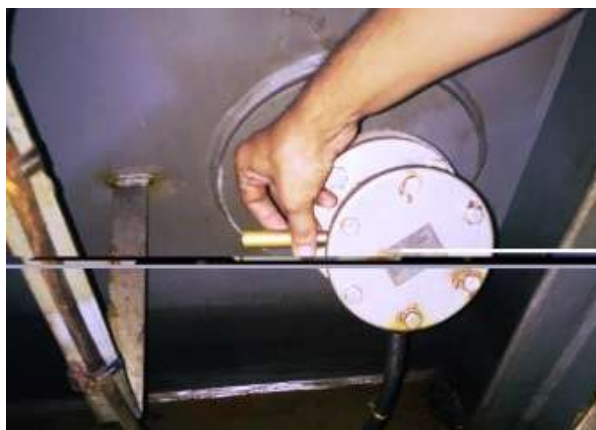
Testing sensor for water ingress alarm
(Image for illustration purpose only)

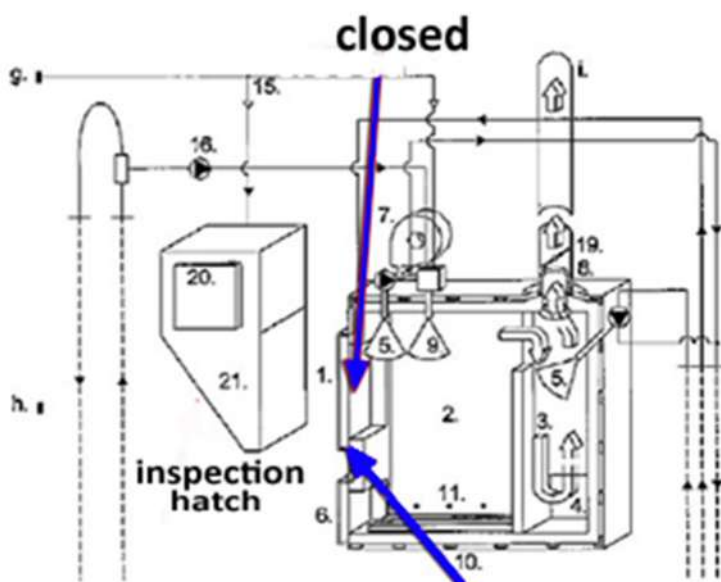
blocking closure of the sluice door. He decided to remove the obstacle manually. However, the sluice door of this incinerator was pneumatically operated instead of the common manual operation. Although power supply to the incinerator was turned 'off', 2nd engineer failed to shut off air supply to the solenoid which controlled operation of the sluice door. Also the pneumatic line was not drained/ depressurized.

As soon as the blockage was removed the sluice door closed immediately, trapping second engineer's hand in the process.

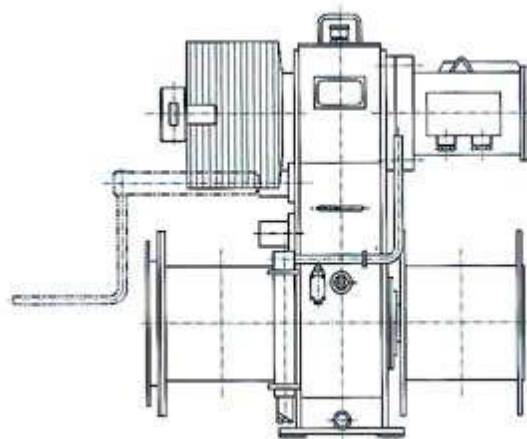
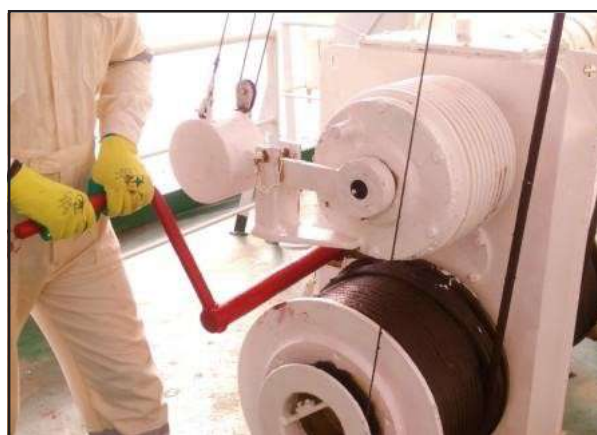
However, soon it was discovered that the electrical hoisting mechanism for the lifeboat was also not functional. Therefore, it was decided to hoist the boat manually while the electrical engineer trouble shoots the fault within the electrical system.

As per his turn, the trainee seaman also came in to participate in heaving. The moment, he put his hands on the handle, electrical engineer, who during this time had made some adjustments on the limit switch, pressed electrical hoisting switch to check its functioning. The electrical hoisting system came live causing the electric motor to rotate. The manually hoisting lever, which is geared to the electric motor, also started rotating at high speed causing the crank handle, which at that time was still connected to it, to also

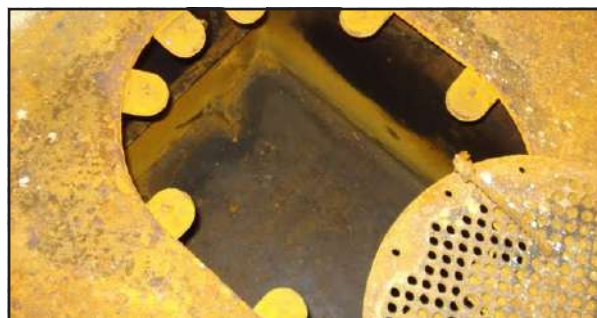
This cover was a perforated steel plate. The perforated steel plate was in addition also covered with single layer of burlap to prevent fine coal muck from entering into the bilge well which could have clogged the suction box.

Washing was progressing normal and all the wash water was being pumped out simultaneously through the bilges. However due to the previous cargo being coal, cargo residues slowly started accumulating on top the bilge cover.

Perforated steel plate

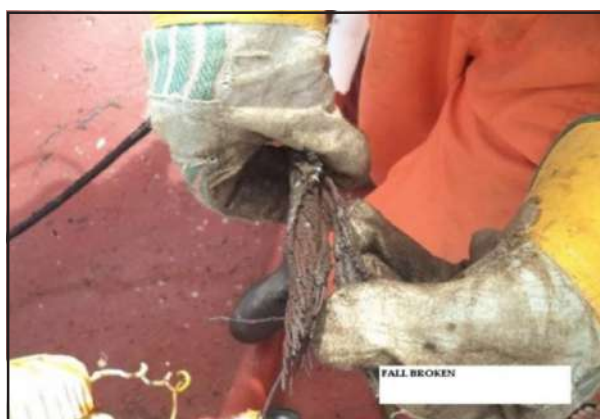
Port side lifeboat was moved out by about one metre from its stowed position. Checks such as free movement of sheaves, functioning of limit switches etc. were made. After successful checks, the lifeboat was being heaved back. It was at this time that wire of the forward fall suddenly broke leaving the lifeboat hanging on its aft hook.

(Parted wire which was fitted as falls)

The entire weight of the lifeboat shifted on to the aft hook with a sudden jerk. As a result, the aft hook got sheared off from the lifeboat's hull resulting in the lifeboat falling freely into the sea underneath.

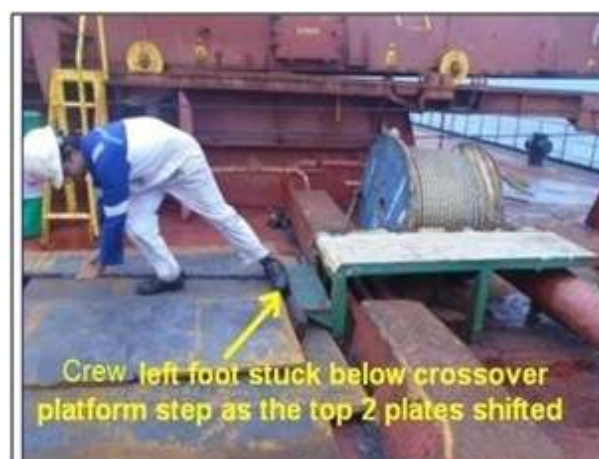
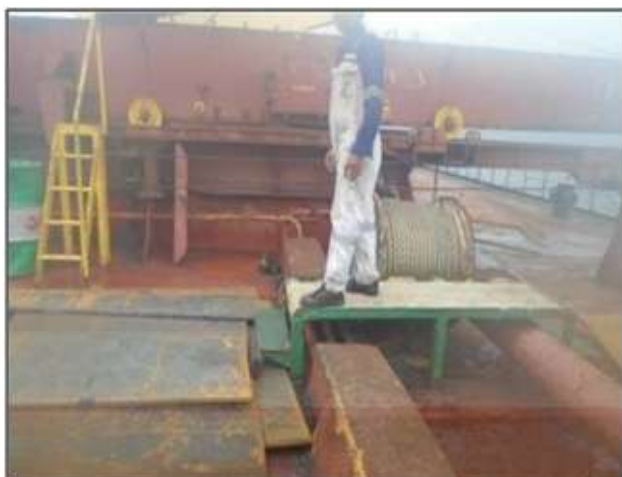
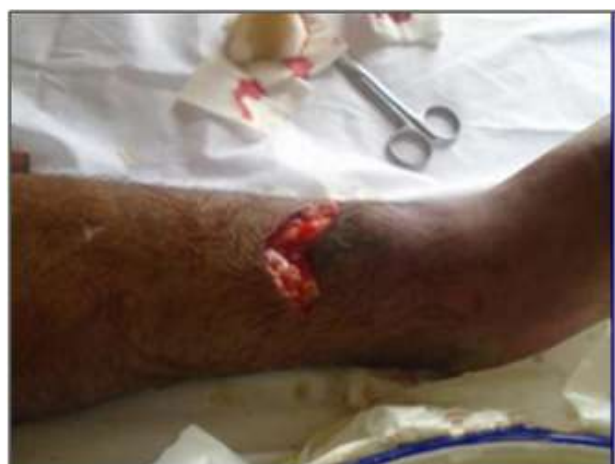
The moment deck cadet had stepped off the walkway, when his left foot had just landed on the main deck, the plates which were lying flat on the deck suddenly shifted due to vessel's roll, pushing his left foot underneath the step. The cadet's leg was trapped under the walkway by heavy plates.

Cadet's leg could be freed with great difficulty using man power. Later cadet was transferred ashore for medical treatment.

Improper securing and lack of basic seamanship. While the hazard of shifting of plates was ever present, no timely mitigating action was taken for the same.

i) Good house keeping, appropriate stowage and adequate securing of all loose items form key elements of safety at sea.

ii) Crew shall be motivated to report any situation or practice that may form a possible hazard. This may be in the form of 'Stop action' card.

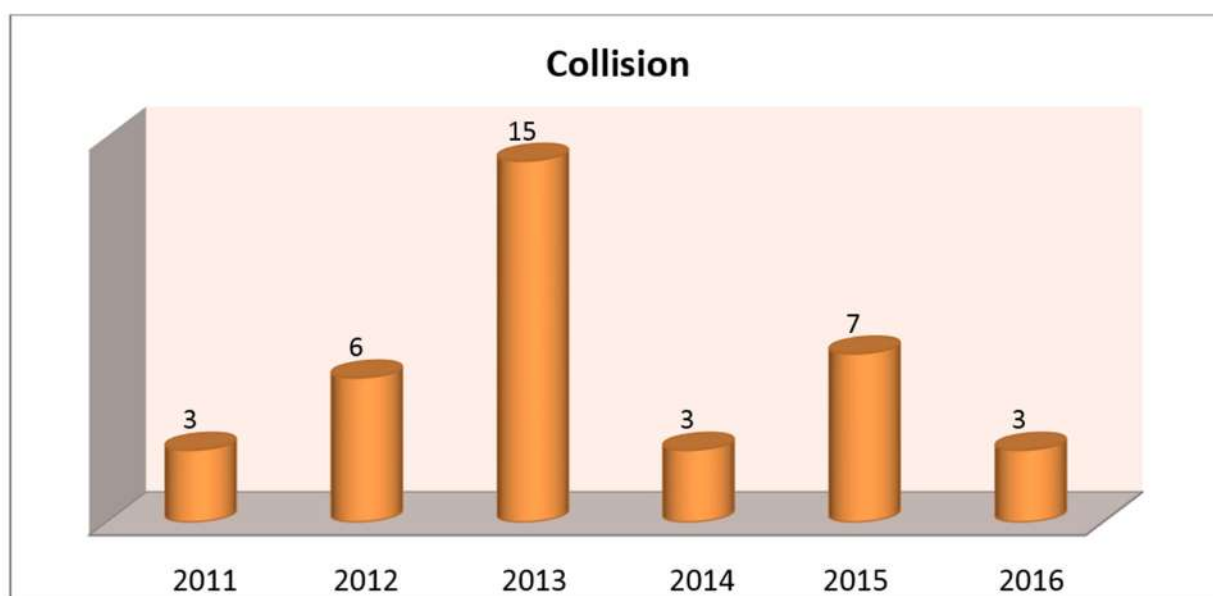
1. Trend Analysis - collision

1.1 After a brief decline in collision incidents in 2014 there was a noticeable increase in 2015.

1.2 Non-adherence to COLREGs, delay in taking appropriate actions and lack of situational awareness remained major causes behind collisions, which involved junior navigating officers. Collisions have also occurred when the vessels were under the direct con of master or senior officers. Such

1.3 Inadequate passage planning has also contributed to collision incidents.

1.5 VTS/ VTMS could have assumed greater role in the avoidance of a couple of collision incidents. Strengthening of such services may be considered.

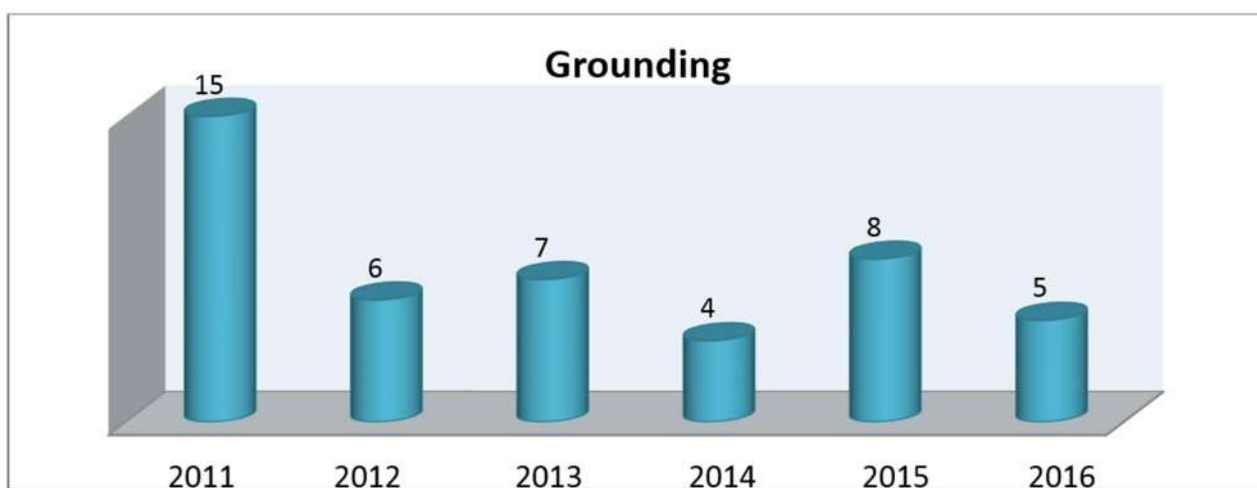
2. Trend Analysis - Grounding

2.1 While improper manoeuvring and underestimation of the effects of weather and currents by the bridge team remained prime causes behind various grounding incidents, there has been an incident where correct depths were not

available with the vessel. Maritime safety information in this regards had not been timely promulgated. The Directorate is strengthening inspections of ports under NSPC, to avoid any such recurrence.

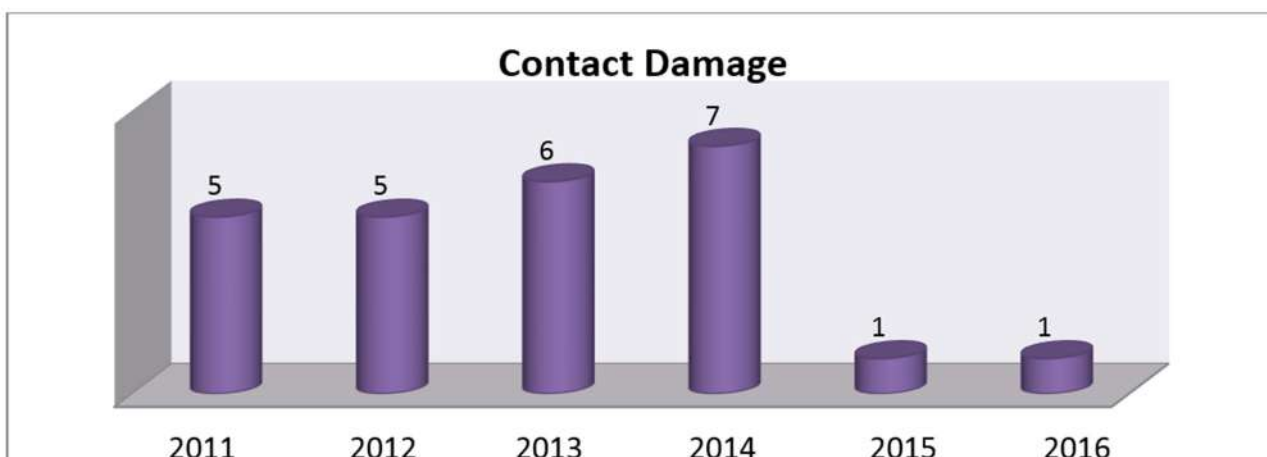
3. Trend Analysis -Contact Damage

3.1 Errors in navigation again appeared as prime factors in contact damages.

3.2 However other than navigational errors, contact damages also occurred due to hardware failures such as parting of tug's lines etc.

3.3 Not keeping safety margins and not having ready a back up plan in case of failure of any equipment also contributed in a few incidents.

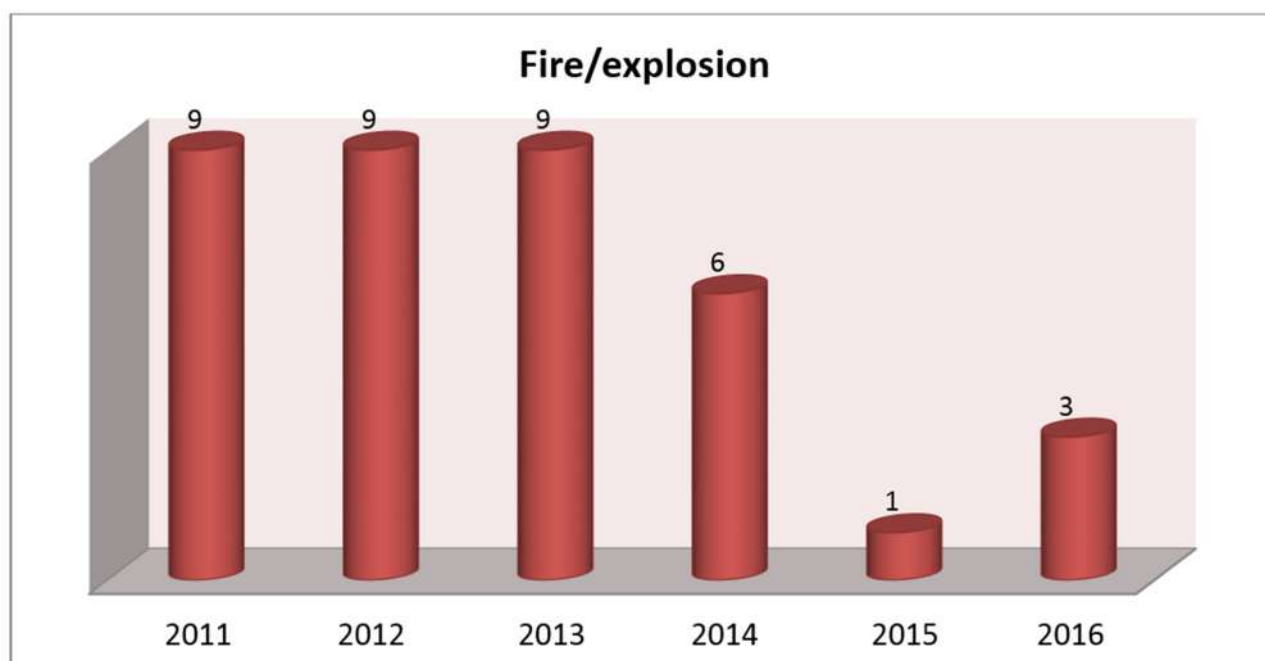
4. Trend Analysis -Fire/ Explosion

4.1 There was a reduction in the number of fire accidents, in particular those involving Indian seafarers, in the past three years however the incidents continued to happen.

4.2 Such fire incidents were spread through different locations on ships, varying from deck to engine room to accommodation. The causes behind such fires were also varied, varying from basic negligence, wherein an iron used for ironing clothes was supposedly left unattended on the bed to major failures in safety procedures such as explosion in a cargo tank during dry docking.

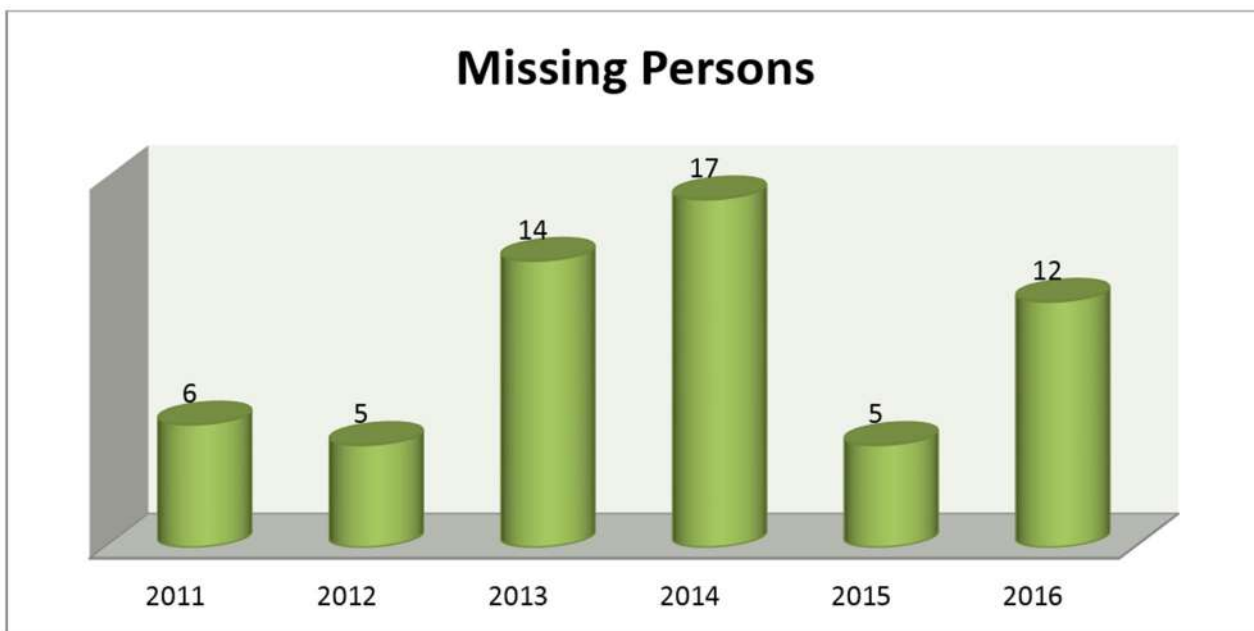
5. Trend Analysis -Missing Persons

5.1 There is an increase in the number of Indian seafarers and passengers who went missing from ships in between 2014 to 2016. While accidentally falling overboard remained prime cause, the reasons remained

unspecified/ unknown in many other missing persons' cases.

5.2 Psychological distress can be one of such unknown factors wherein the missing person may have taken suicidal steps.

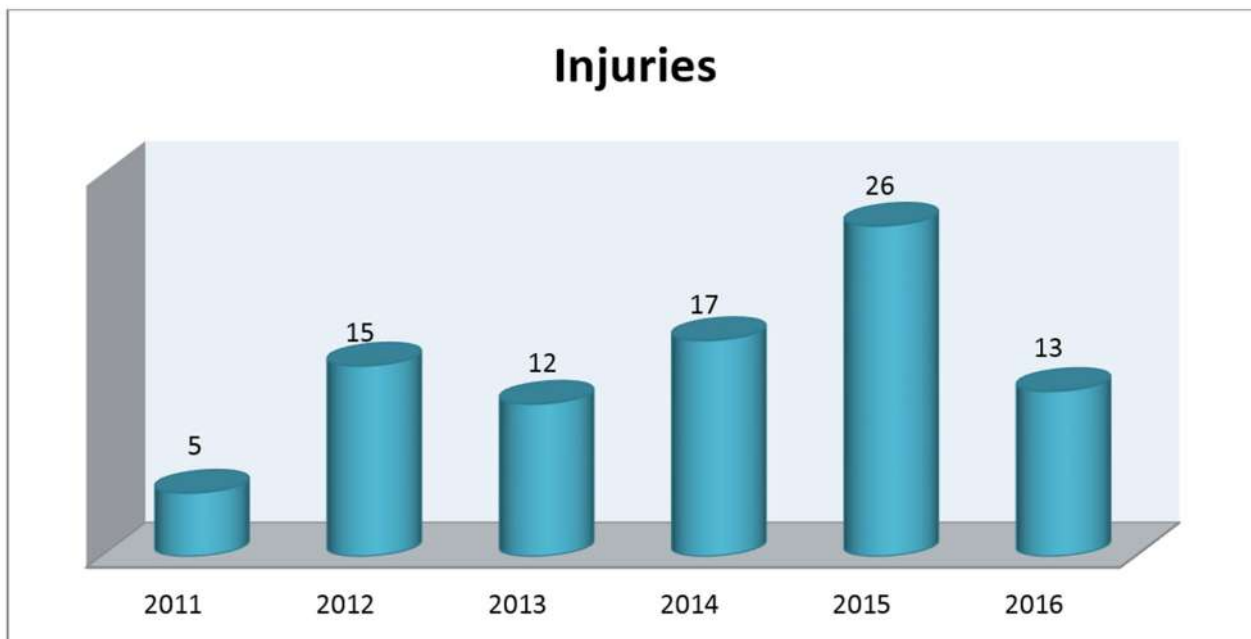
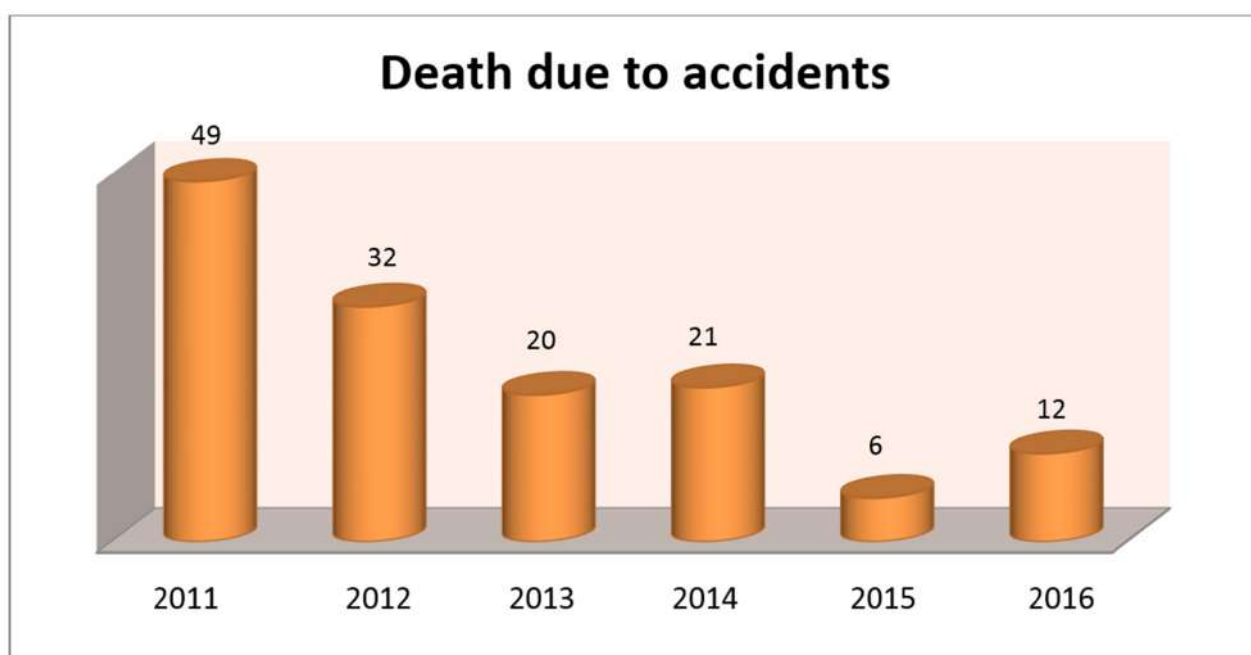
7. Trend Analysis -Injuries and Accidental deaths

7.1 There is a noticeable increase in the number of injuries, which is worrisome. Although the number of accidental deaths declined, still it remains unacceptable.
