DGS Circular 46 of 2025

Casualty Branch Circular – 05 of 2025

Collision / Contact damage between

MANTA NIGAR and JAG RADHA at P & V anchorage, Mumbai on 02.08.2024

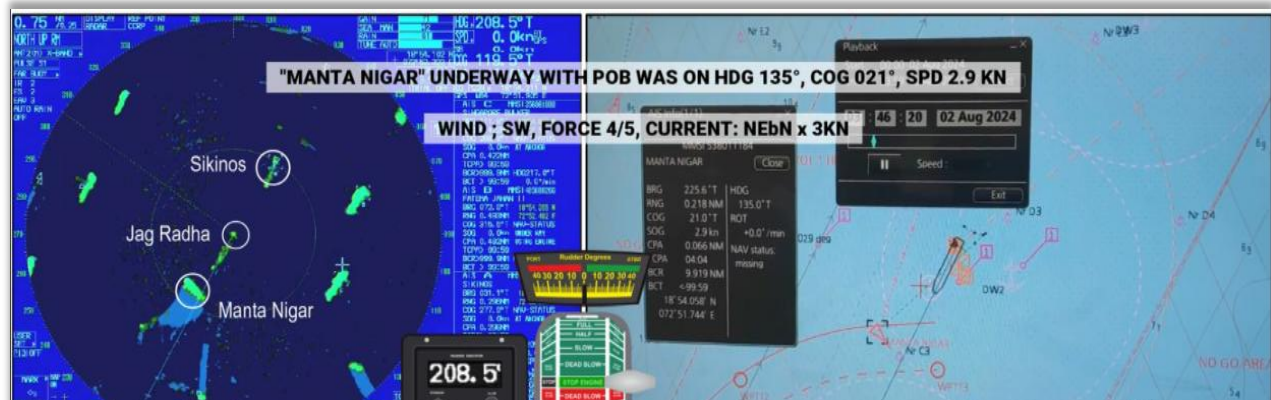
Figure 3 Radar and ECDIS picture of Jag Radha

At 0919 hours, while manoeuvring towards the berth, the M.V. Manta Nigar's propeller became entangled with the port anchor chain of the anchored vessel M.V. Jag Radha. As a result, M.V. Manta Nigar's port quarter struck M.V. Jag Radha's port bow in the forecastle area. The master and pilot of M.V. Manta Nigar immediately stopped the engine.
