MARINE SAFETY INVESTIGATION REPORT -HALF YEARLY

— January - June (2025)

DIRECTORATE GENERAL OF SHIPPING
MINISTRY OF PORTS, SHIPPING & WATERWAYS
GOVERNMENT OF INDIA

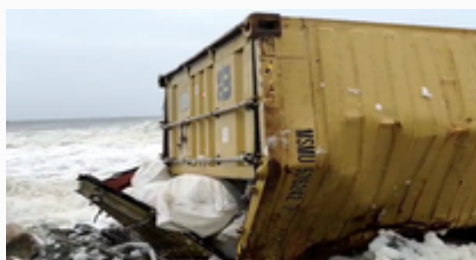
CONTAINER HAZARDS AND MANAGEMENT

The loss of containers created navigational and community risks, with 66 units washing ashore. Public advisories were issued immediately, and fishing boats were mobilised to assist in retrieval. ITOF carried out drift modelling to anticipate container landings, ensuring resources were positioned effectively for recovery.

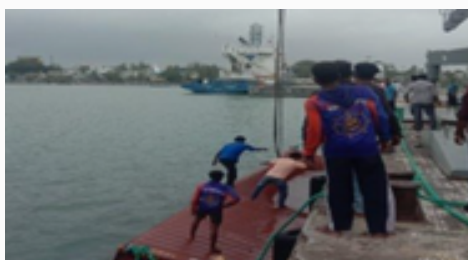
POLLUTION CONTROL AND ENVIRONMENTAL SAFEGUARDS

Oil seepage was managed through air diving operations that sealed vents and sounding pipes. Anti-pollution vessels were deployed for monitoring and containment, while salvage teams prepared for large-scale recovery. SMIT Salvage was engaged to oversee oil extraction using specialised equipment, keeping the risk of a major spill under control.

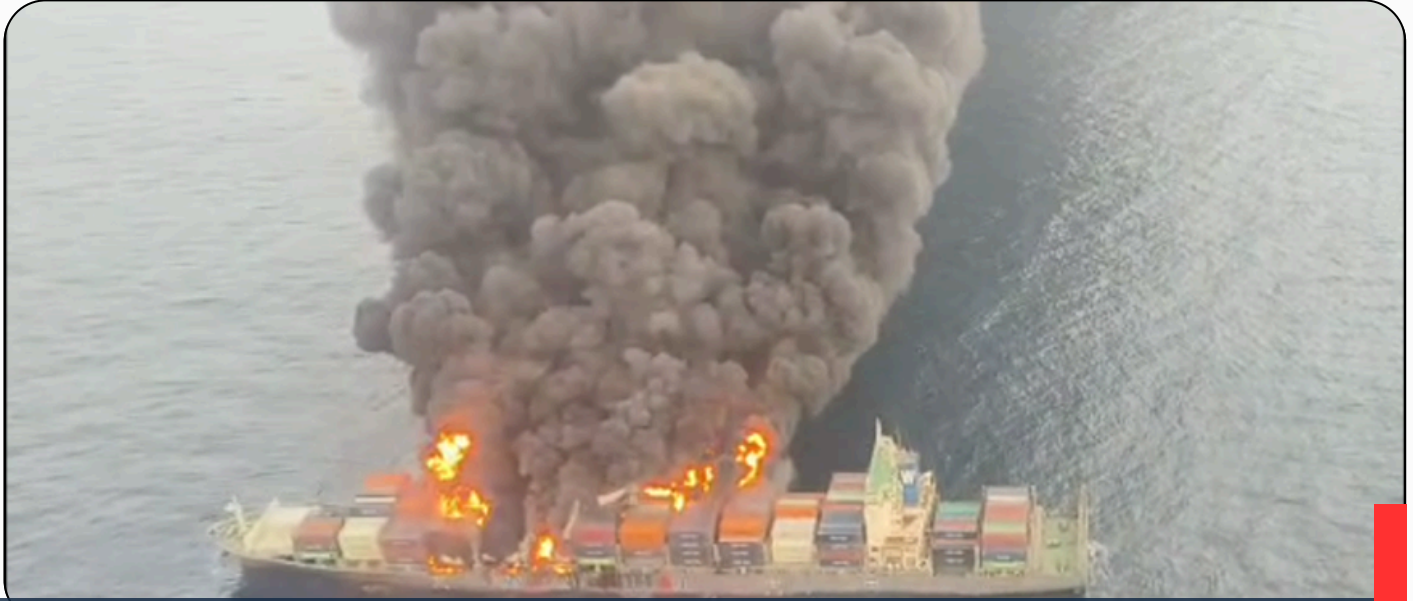
FIRE ONBOARD WAN HAI 503

On 9th June 2025, a major fire broke out onboard the Singapore-flagged container vessel WAN HAI 503 while transiting the Arabian Sea. The incident occurred in Cargo Hold No. 4, leading to multiple explosions and heavy smoke. The vessel carried a crew of 22, approximately 2000 tonnes of fuel oil, and 240 tonnes of diesel, posing serious risks of escalation.

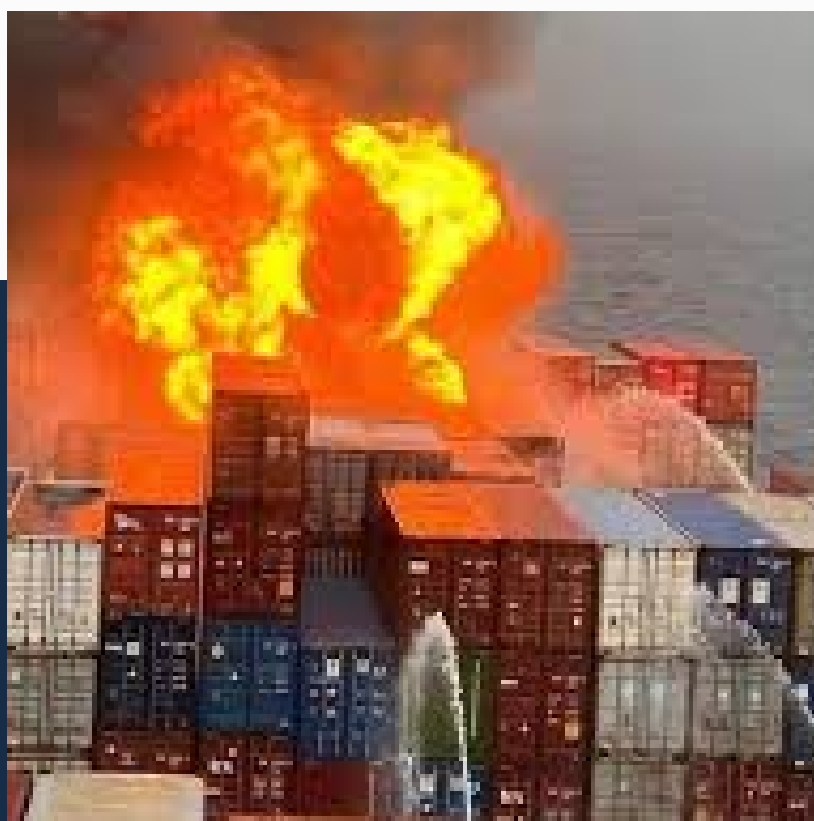
Immediately upon receiving the report, the Directorate General of Shipping (DGS) instructed the vessel to maintain a minimum 50 NM distance from the Indian coastline to safeguard coastal and environmental safety. The Indian Coast Guard (ICG) deployed vessel CG18 to assist in boundary cooling and support the crew's firefighting efforts. Ship-owners, in consultation with their P&I Club, appointed the professional salvor, with firefighting experts mobilized from Singapore to Kochi. By 14 June 2025, the fire was fully extinguished, and continuous flooding and cooling operations were underway as a precautionary measure.

Following the container fire onboard INTERASIA TENACITY, several preventive and control measures were undertaken to mitigate risks associated with hazardous cargo and vessel safety. Boundary cooling and internal temperature monitoring were continuously maintained to prevent re-ignition. Firefighting foam and CO₂ systems were deployed strategically to isolate the affected cargo hold and limit thermal spread.

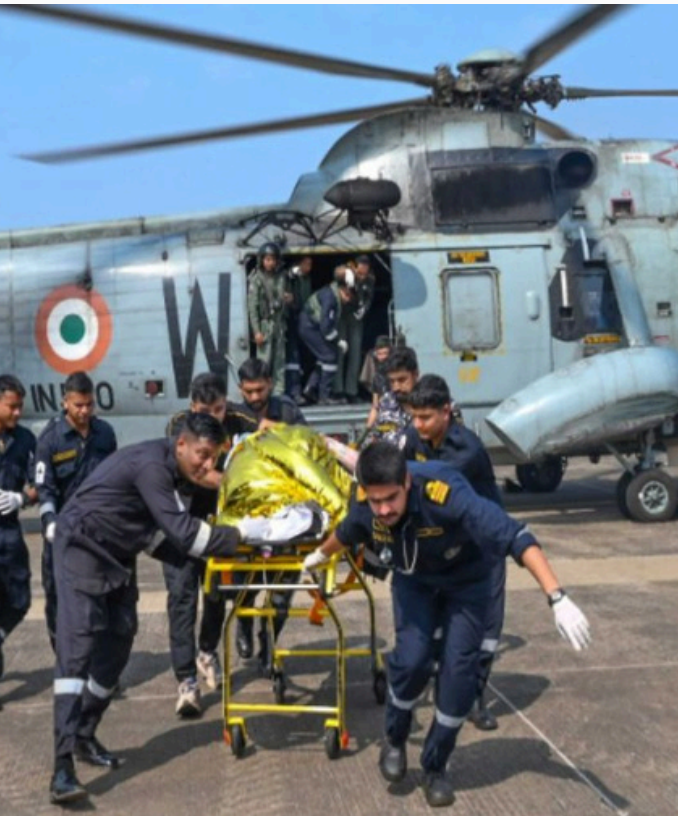
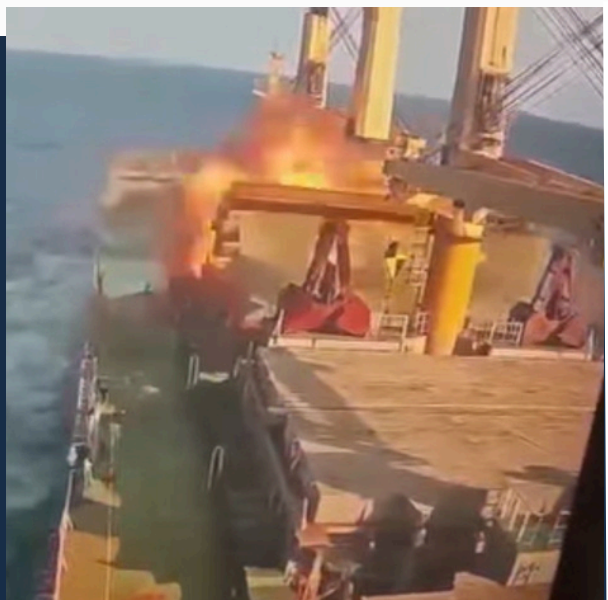
An explosion occurred in cargo hold no.3, on the bulk carrier MV Heilan Star, at around 1647 LT on 20 March 2025, while the vessel was around 230 nautical miles west of Goa. The vessel had departed from its load port of Jubail, Saudi Arabia and was bound for Huanghua in China. The explosion caused the hatch cover to lift. The C/E, 2/E, 4/E and Motorman were repairing the hydraulic jack cylinder of no. 2 cargo hold and were using a handheld cutting tool near the forward manhole cover of no.3 cargo hold. The flames due to the explosion caused severe burns to the above crew members.

- Evidence of oxygen depletion, evolution of flammable gasses from cargo resemble properties associated with Direct Reduced Iron (DRI).
- The cargo as per shipper's declaration was "Iron ore pellet chips and fines". This cargo is supposed to be non-hazardous and as such ventilation of cargo holds was not carried out. Neither were levels of O₂, flammable gases and temperatures of the cargo holds being measured by the ship's staff.
- The cargo was likely to be direct reduced Iron (DRI) or at least contain some DRI which was not declared by the shipper. DRI is associated with O₂ depletion, self-heating & accumulation of explosive gases.
- The self-heating of cargo together with accumulation of explosive gases in hold no.3 apparently led to the explosion.

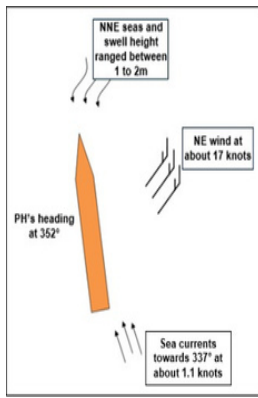
Figure 1: Illustration of the weather and sea conditions relative to PH at 0800 Hrs.
(Source: TSIB report)

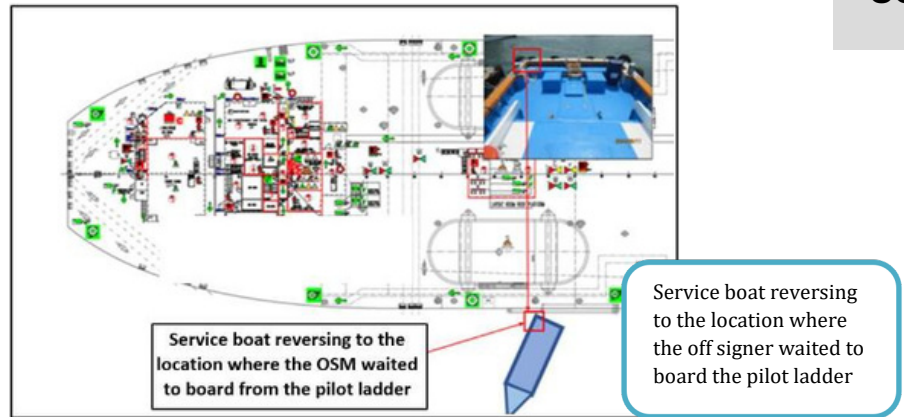
Figure 2: Indicating the service boat angle of approach. Source: TSIB report

The service boat was unable to rescue him due to the rough seas. He was later recovered by the Korea Coast Guard in an unconscious state and taken to the hospital, where he was declared dead upon arrival.
